**DEPARTMENT OF TRANSPORTATION****DIVISION OF ENGINEERING SERVICES**

Contract #: 04-0120F4Cty: SF/ALA Rte: 80 PM: 13.2/13.9File #: 1.28**WELDING INSPECTION REPORT****Resident Engineer:** Pursell, Gary**Address:** 333 Burma Road**City:** Oakland, CA 94607**Report No:** WIR-012926**Date Inspected:** 02-Apr-2010**Project Name:** SAS Superstructure**OSM Arrival Time:** 900**Prime Contractor:** American Bridge/Fluor Enterprises, a JV**OSM Departure Time:** 1730**Contractor:** American Bridge/Fluor Enterprises, a JV**Location:** Job Site**CWI Name:** See Below**CWI Present:** Yes No**Inspected CWI report:** Yes No N/A**Rod Oven in Use:** Yes No N/A**Electrode to specification:** Yes No N/A**Weld Procedures Followed:** Yes No N/A**Qualified Welders:** Yes No N/A**Verified Joint Fit-up:** Yes No N/A**Approved Drawings:** Yes No N/A**Approved WPS:** Yes No N/A**Delayed / Cancelled:** Yes No N/A**Bridge No:** 34-0006**Component:** Orthotropic Box Girders**Summary of Items Observed:**

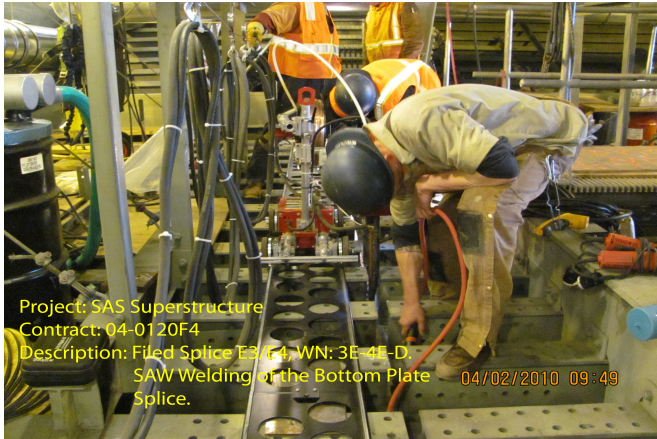
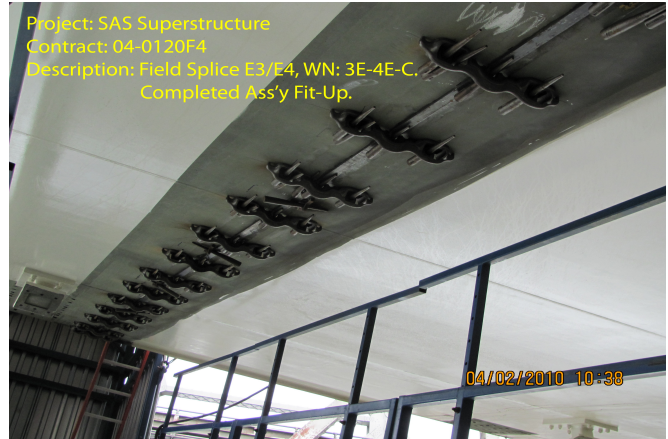
The digital photographs on page 3 of this report, illustrates the work observed during this scheduled shift.
